U. S. DEPARTMENT OF AGRICULTURE  
FOREST SERVICE  
WASATCH NATIONAL FOREST

ALTA AVALANCHE STUDY CENTER

Miscellaneous Report No. 3

MAN-MADE NOMINAL WIND ACTION AREA

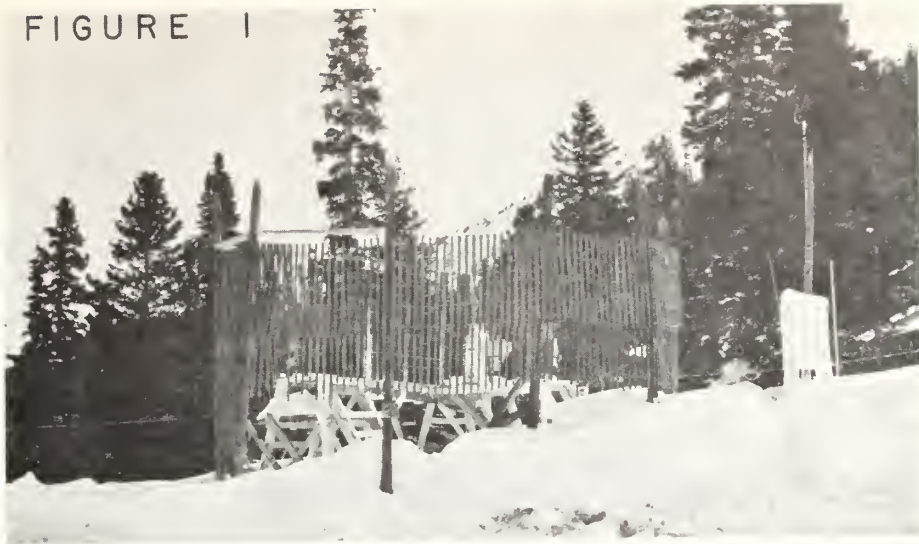
FIGURE 1

Shows general overall installation of the snow fence to make a man-made nominal wind action area.

Note the difference in snow depth under the fence at the right of the photo and at the left of the photo. The left side of the photo is northerly and the edge of the installation is on the edge of the fill which drops off for about 10 ft. The northern high speed winds come up the fill bank and under the fence causing much scouring.

See photos. A somewhat circular design was selected. Posts about 20' long were set 3' in the ground and spaced 6' apart. Standard snow fencing was then installed on the posts. The lowest fence was installed leaving a 6' gap between the ground and the bottom edge of the fence. It was thought that perhaps this gap would induce scouring under the fence and data collection table so that shoveling out would be kept to a minimum. As was expected, shoveling was not necessary, but next year

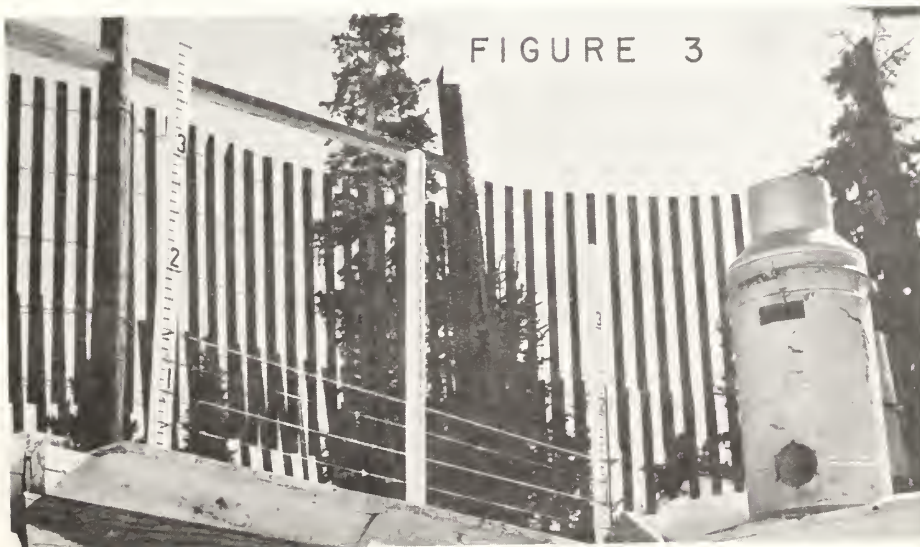
FIGURE 3

New snow stakes and settlement gauge.

1. During the latter part of February, the 775-B was moved to a more central location within the fenced diameter.
2. The 6' ground to snowfence gap was reduced by snow accumulation. (See photo taken on April 10, 1962, Maximum Accumulation Stake Reading.)
